NOTICE OF VIOLATION #5576E

Photograph Enclosure for NOV #5576E
Greenleaf, L.L.C.
Neosho, MO

TO: Hazardous Waste Enforcement File
Greenleaf, L.L.C.
Neosho, Missouri
MOR000526152

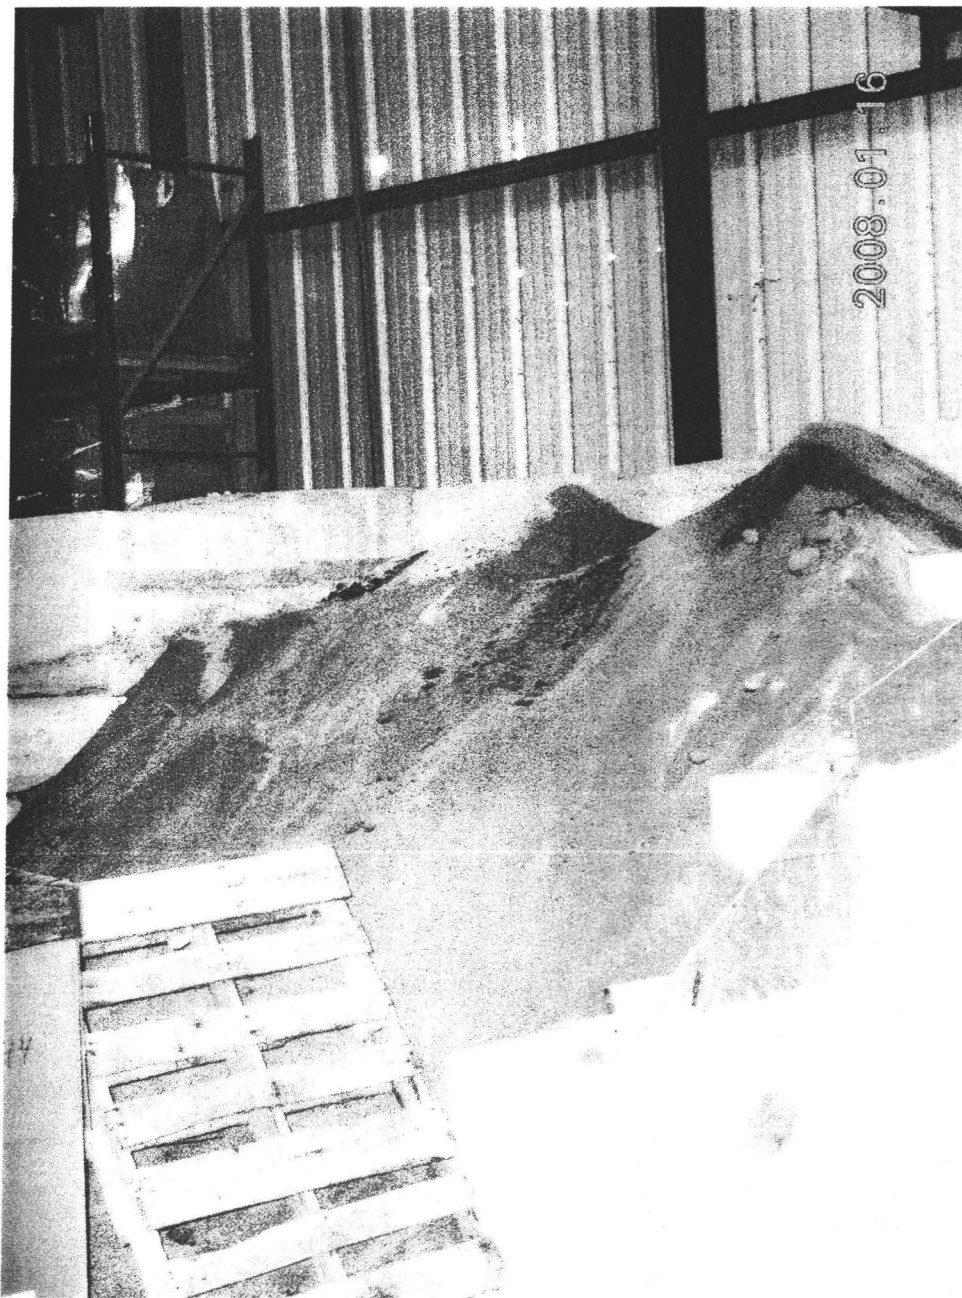
View of Pile 1 in Building 1. The pile is granular pesticide under the SSURO. The dry pesticide is from several different sources including Sevin, which contains carbaryl, a U279 listed hazardous waste.

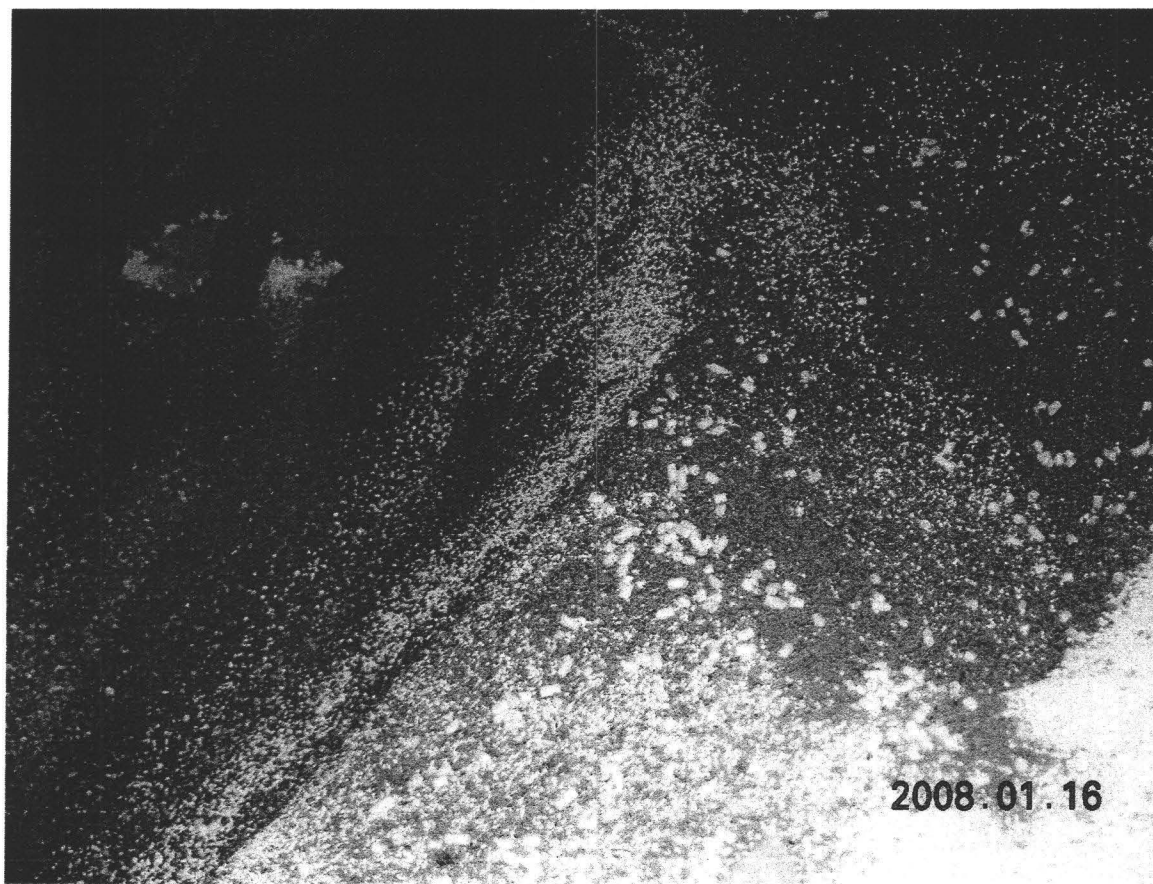
Up close view of Pile 1 in Building 1. The pile is granular pesticide placed under an EPA SSURO. The dry material is from several different sources. Note multiple colors and sizes of grains.

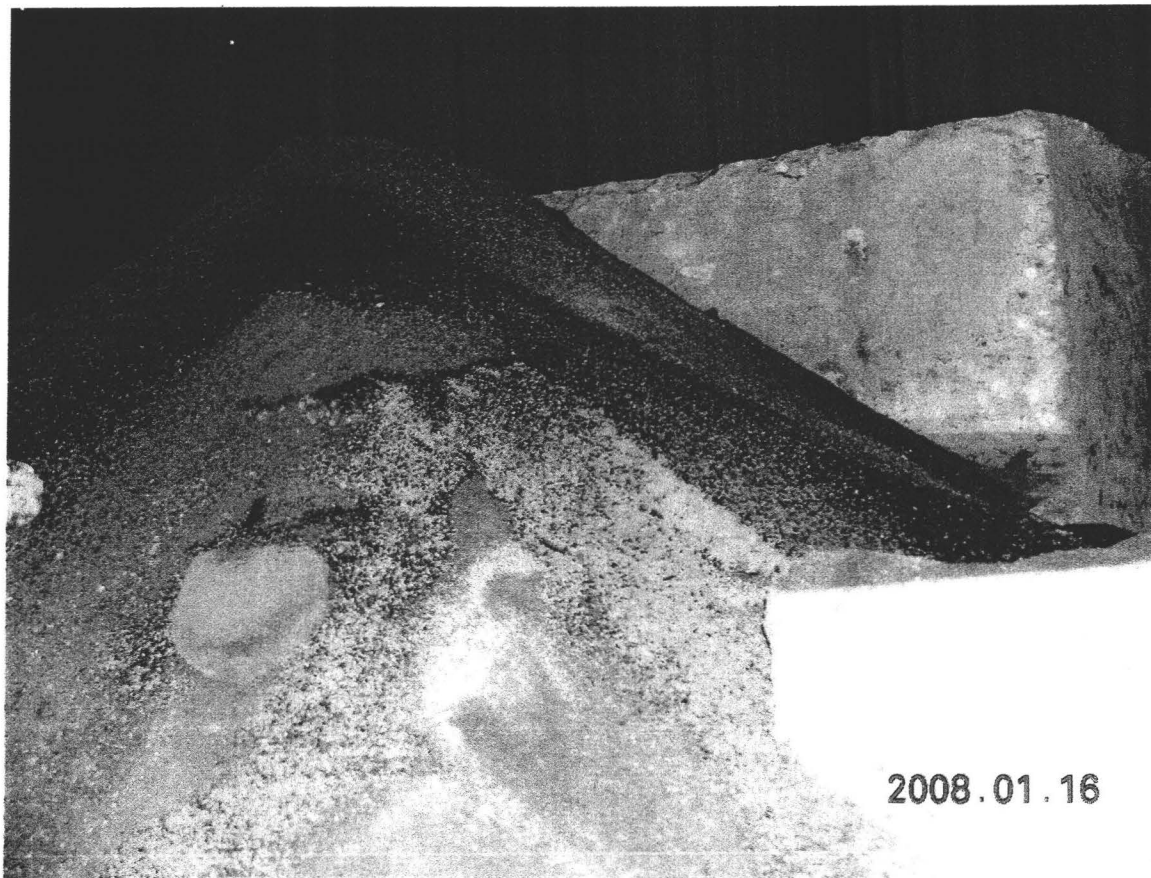
Up close view of Pile 1 in Building 1. The pile is granular pesticide placed under an EPA SSURO. The dry material is from several different sources. Note multiple colors and sizes of grains.

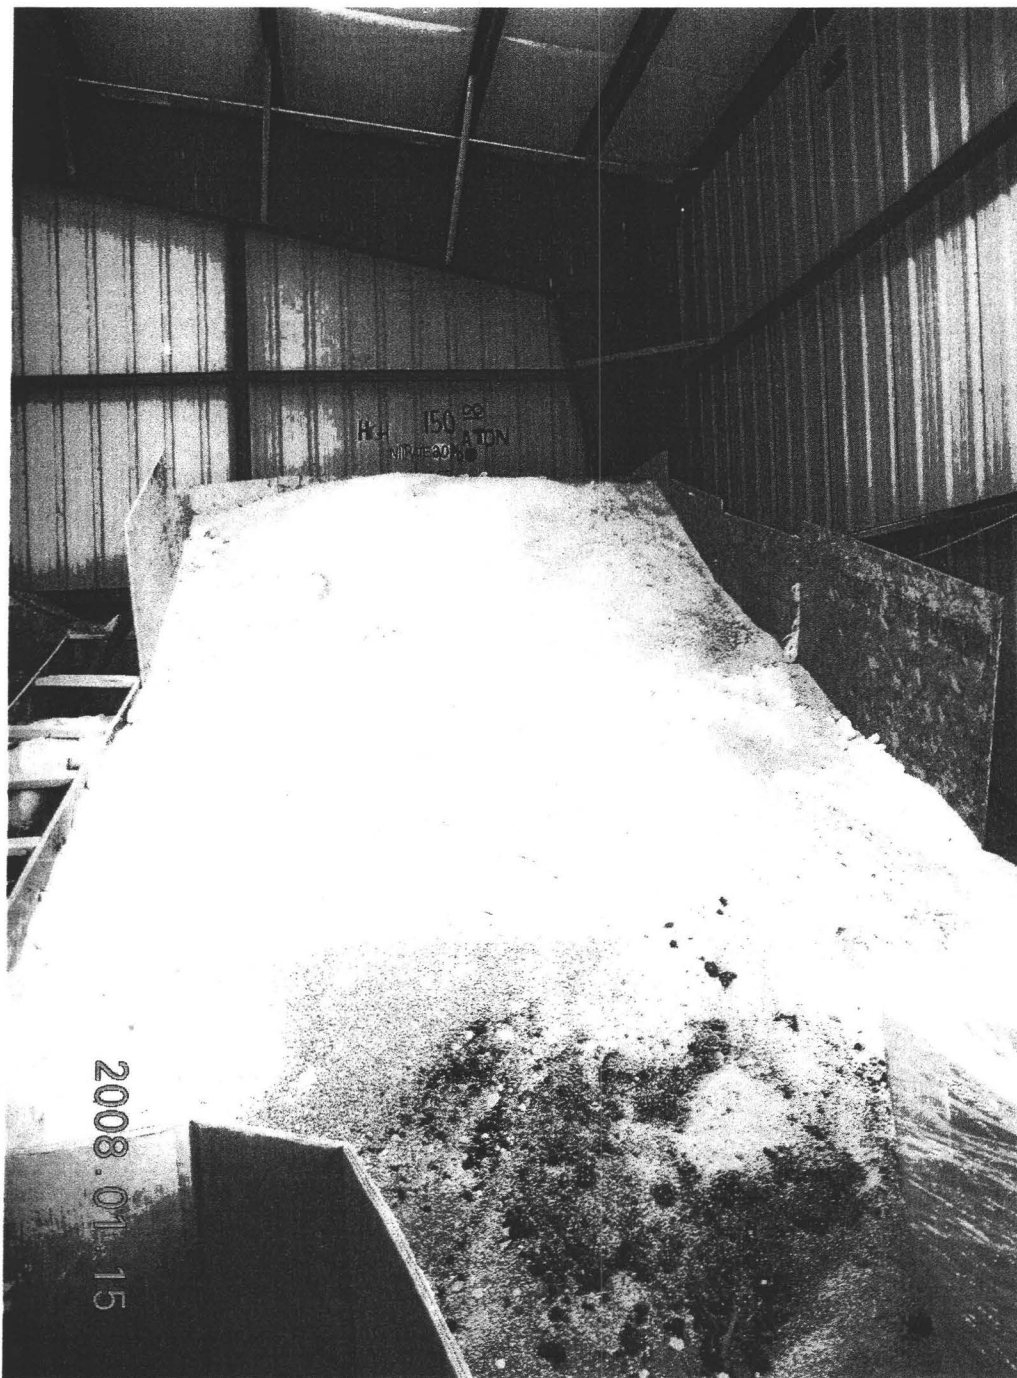
View of granular material in Pile 4 in Building 1. The dry fertilizer with herbicide is from several different sources. The pile contains 2,4-D.

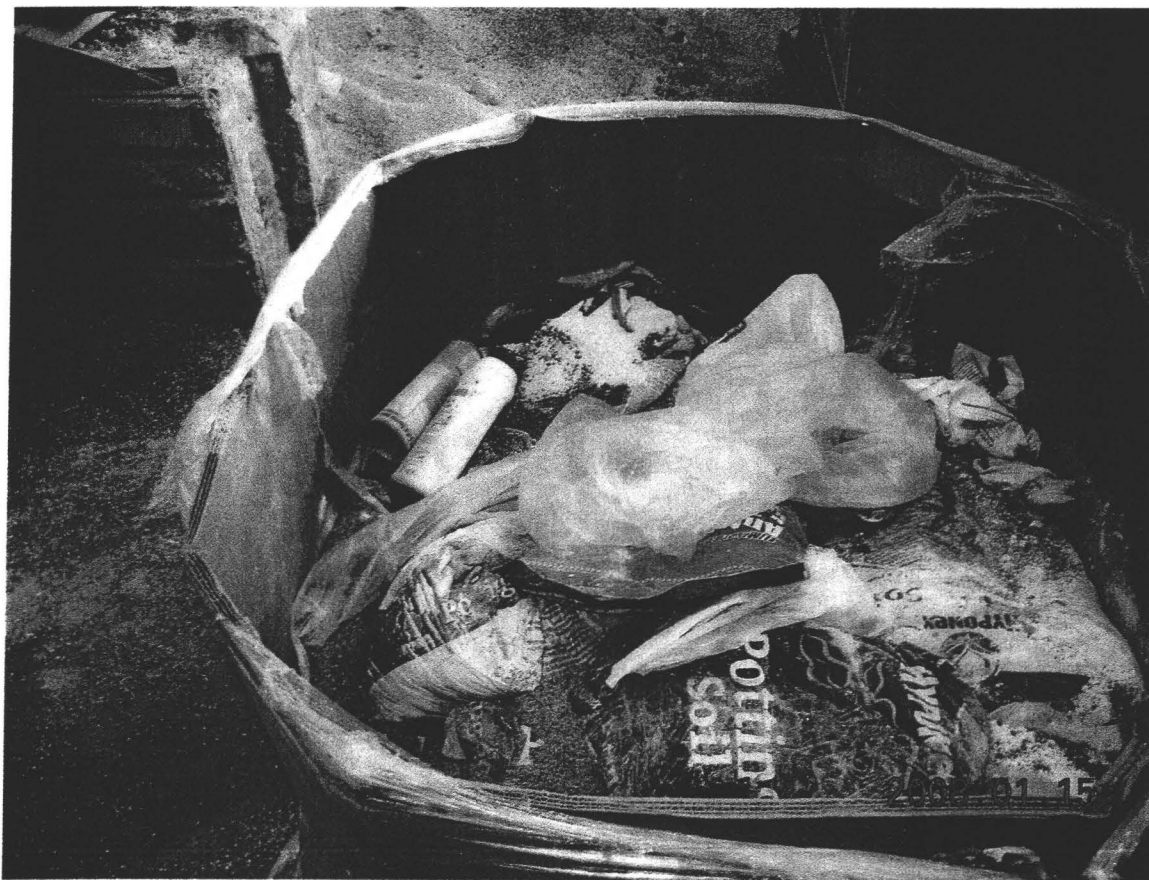
View of Gaylord box with spilled pesticides and unidentified bags in Building 1.

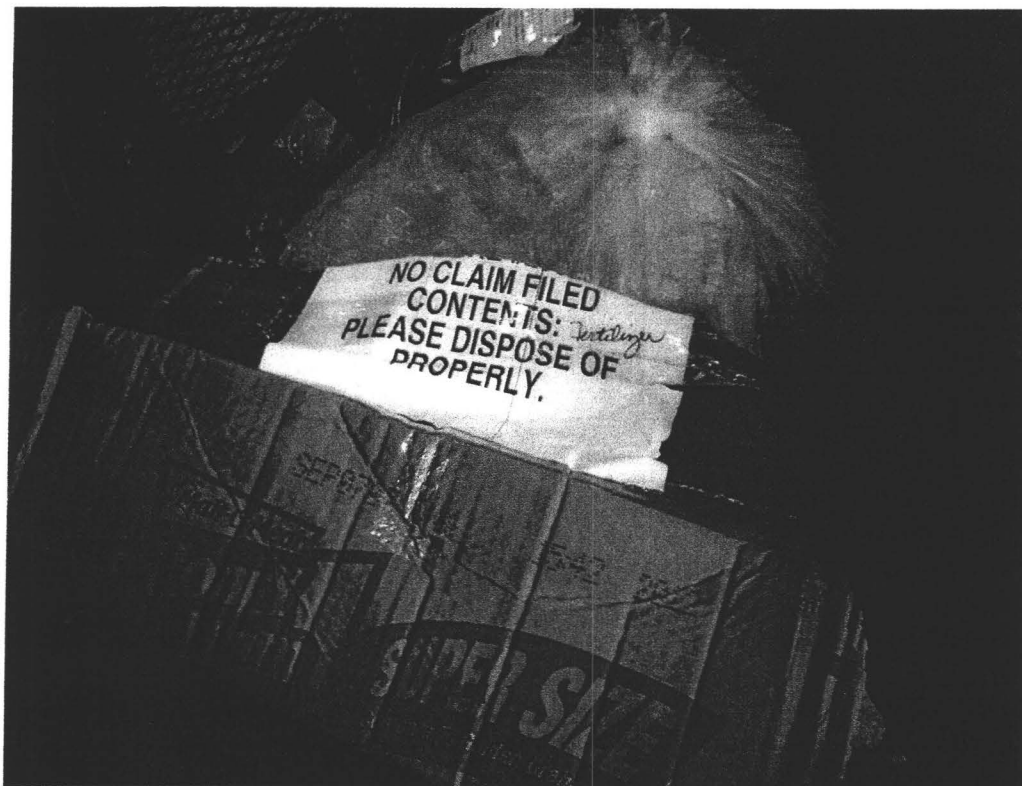
View of unidentified material marked for disposal in Building 1.

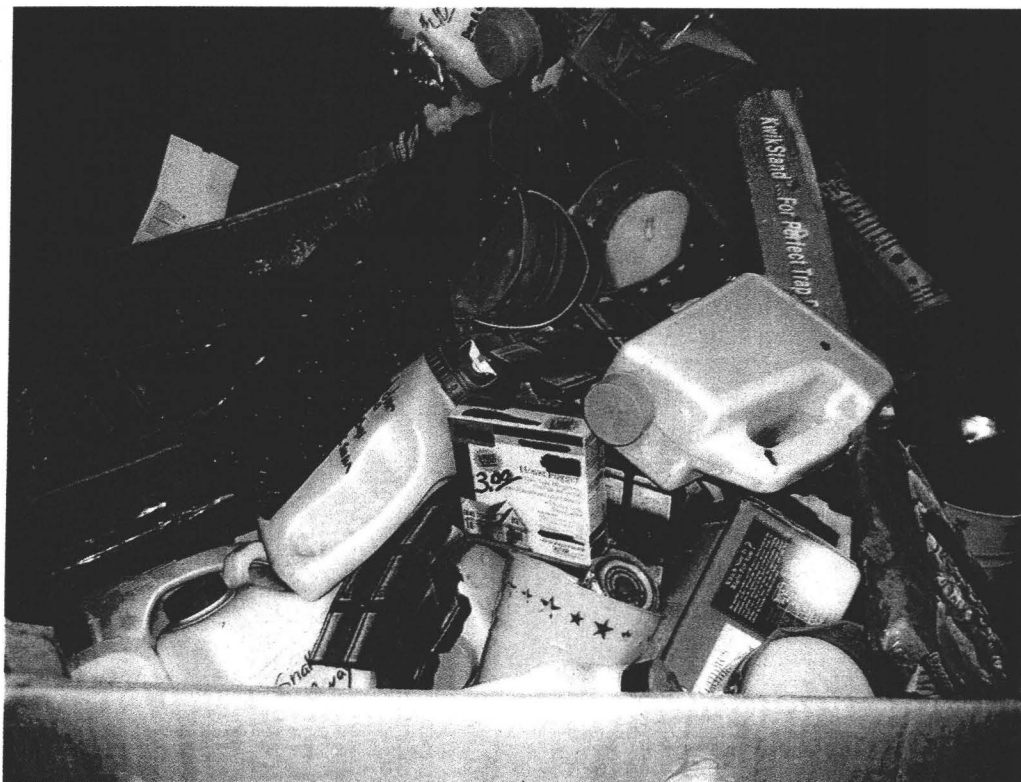
View of waste located near SSURO items in Building 1.
